Castle Rock
Reservoir Dams,
Rosebud County,
Montana, Main Dam,
MT-1982, Saddle
Dam, MT-3146

**INSPECTION REPORT
NATIONAL DAM SAFETY PROGRAM**

**Christian, Spring, Sielbach & Associates
Bozeman, Montana**

June 1981

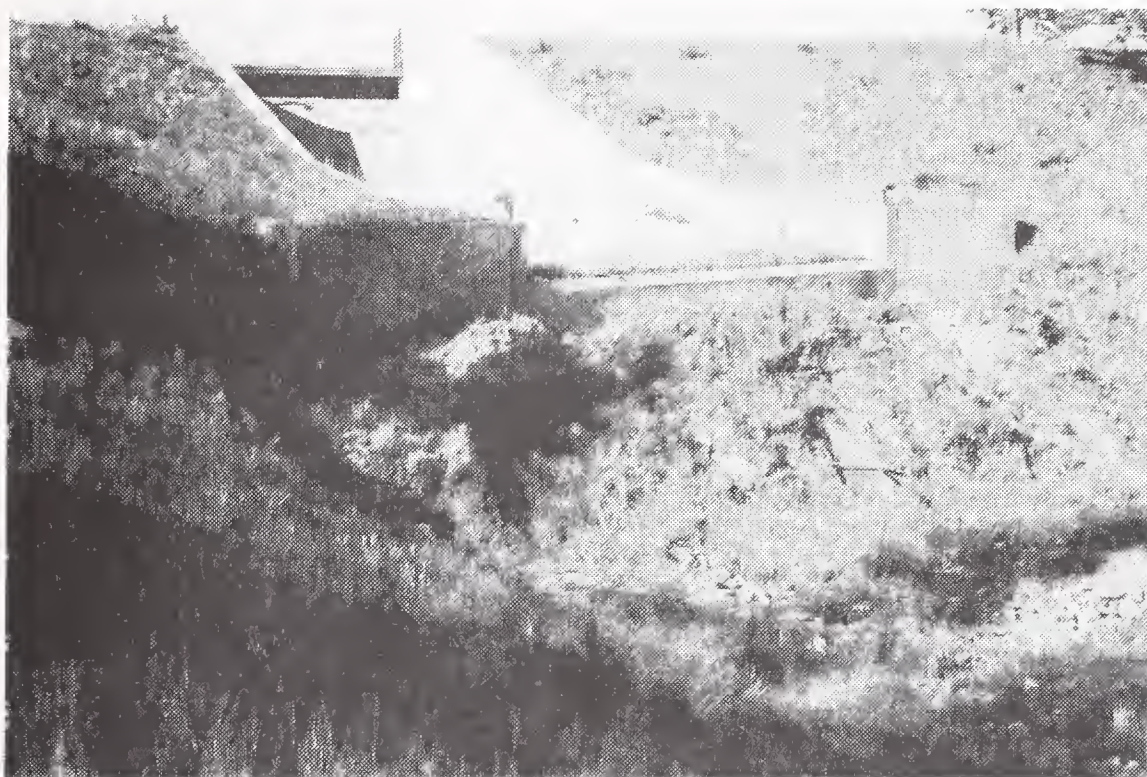
PHOTO 1
Spillway Outlet
(Note erosion potential)

Inspect the outlet works conduit beneath the dam embankment and make repairs if necessary. Repair erosion damage along emergency spillway chute sidewalls, and at the outlet of the concrete chute. Repair runoff erosion damage on the downstream left abutment contact and along the downstream toe of the embankment. Provide riprap or other wave protection along the saddle-service road between the left abutment and the emergency spillway.

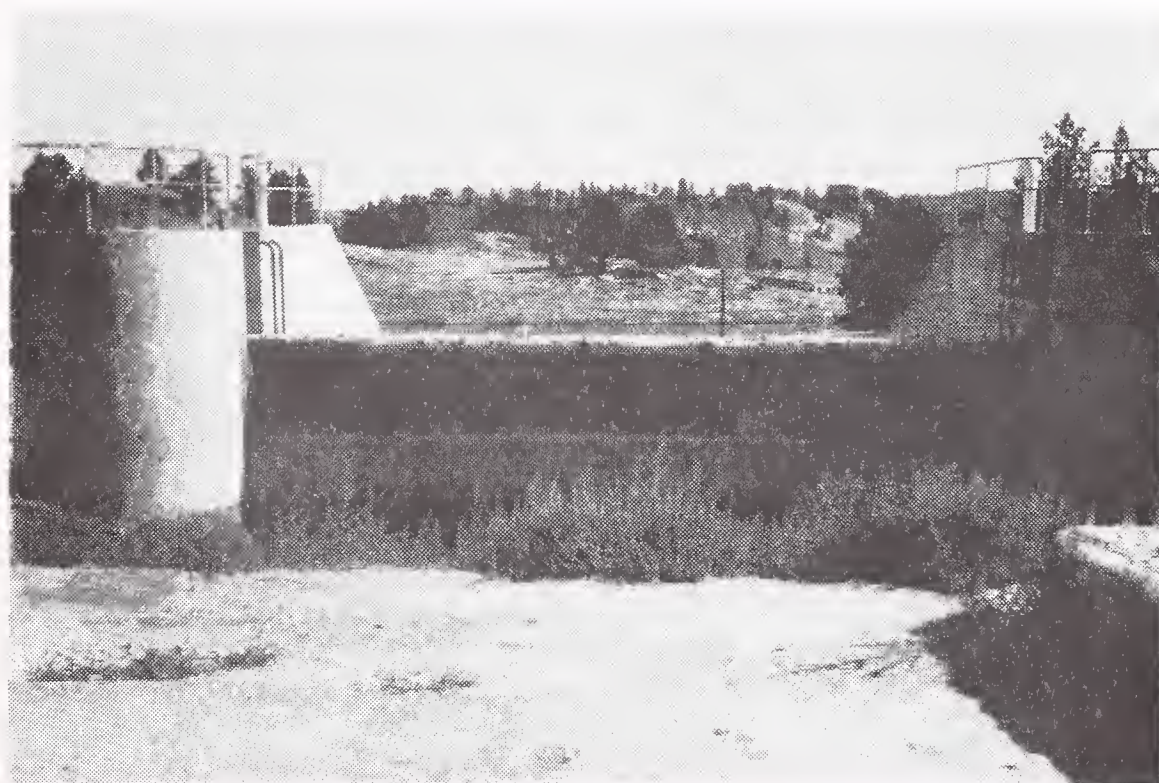
PHOTO 2
Spillway Inlet

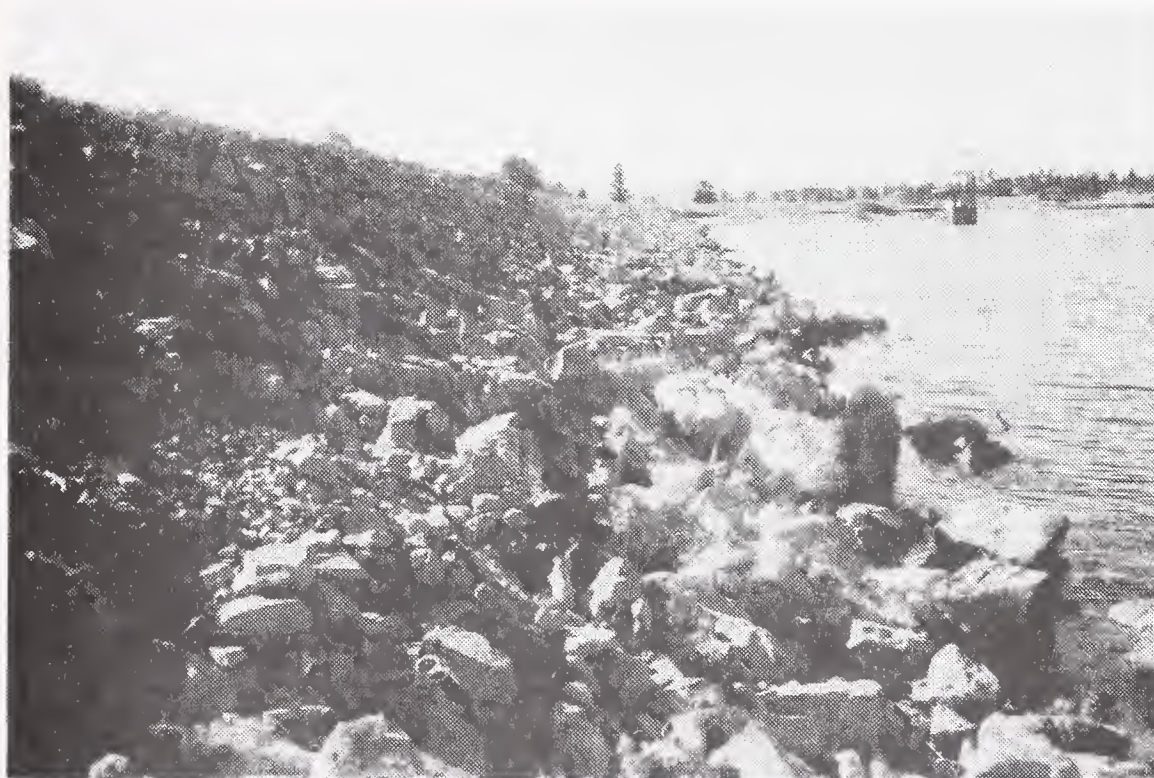
PHOTO 3
Upstream Face of Main Dam Showing Riprap

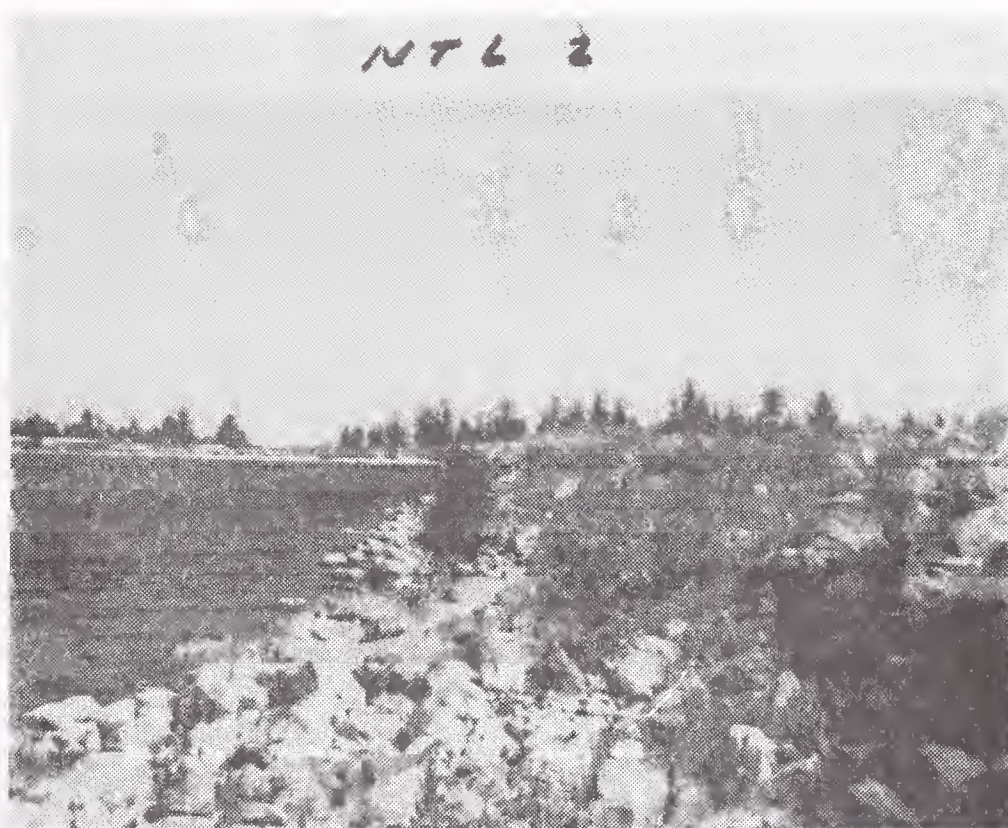
PHOTO 4
Upstream Face of Main Dam Showing Steepened Section

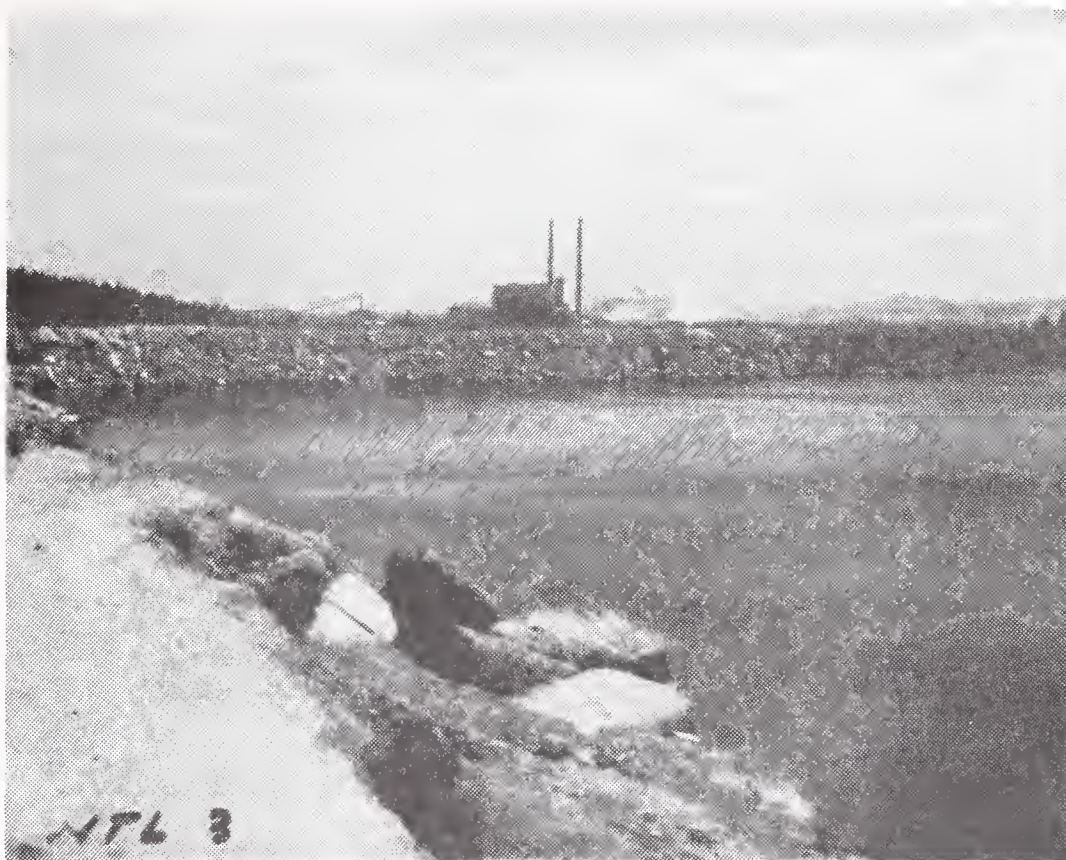
There is no evidence of settlement, cracking, misalignment or traffic damage on the dam crest. Though most of the exposed upstream slope above water surface was riprapped, no cracking was observed or indicated. However, this exposed portion exhibited some profile irregularities. From approximately 600 feet to 200 feet left of the right abutment, the 1V on 3.5H upstream slope (Photo 4) has been steepened and benched, possibly due to disturbance during subsequent construction of the slurry wall. Riprap does not completely cover the slope face in the benched area. Other irregularities were observed near the left abutment. The 100 feet of upstream slope immediately right of the left abutment has been steepened to about 1V on 1.5H for the upper 10 feet, to accommodate crest widening. Riprap in this area is baked shale material grading from less than 6 inches to greater than 18 inches in diameter. This may have been the material used to widen the crest. Immediately west of the abutment contact along the saddle-service road fronting the emergency spillway considerable wave erosion has occurred (Photo 5).

PHOTO 5
Wave Erosion - Main Dam

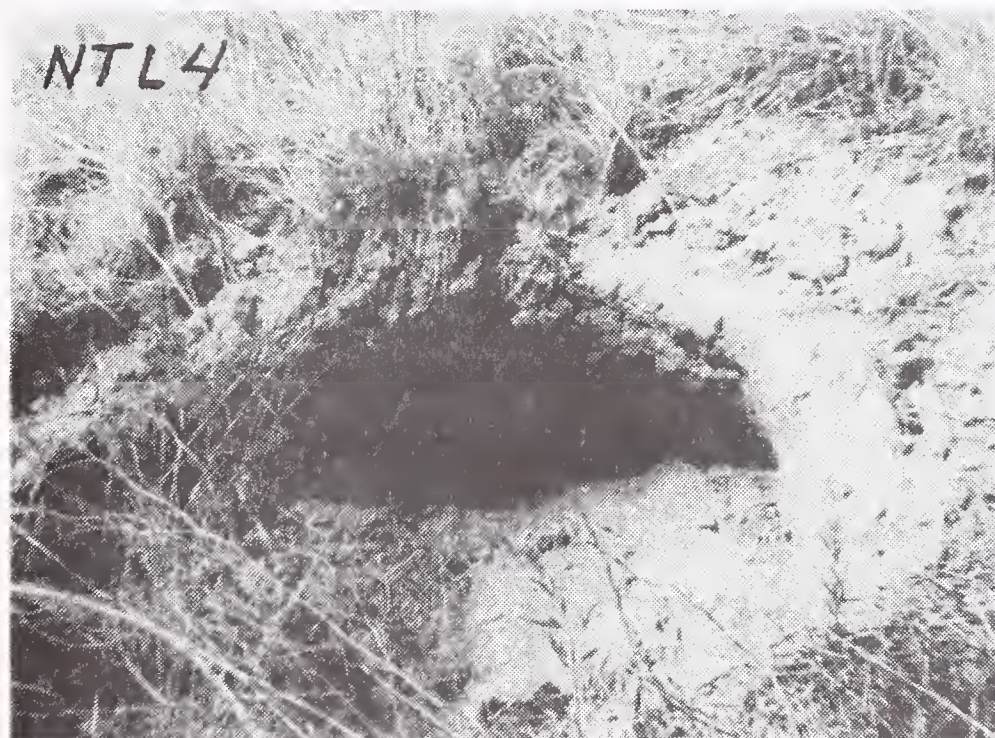
No cracking or settlement was found on the downstream slope. Runoff has eroded rills 1 to 6 inches deep over some of the slope, where vegetative cover is thin, but has not caused significant deviation from the 1V on 2.5H slopes. There is some minor cutting at the embankment toe. Scattered animal burrows were noted. (Photo 4)

PHOTO 6
Animal Burrows - Main Dam

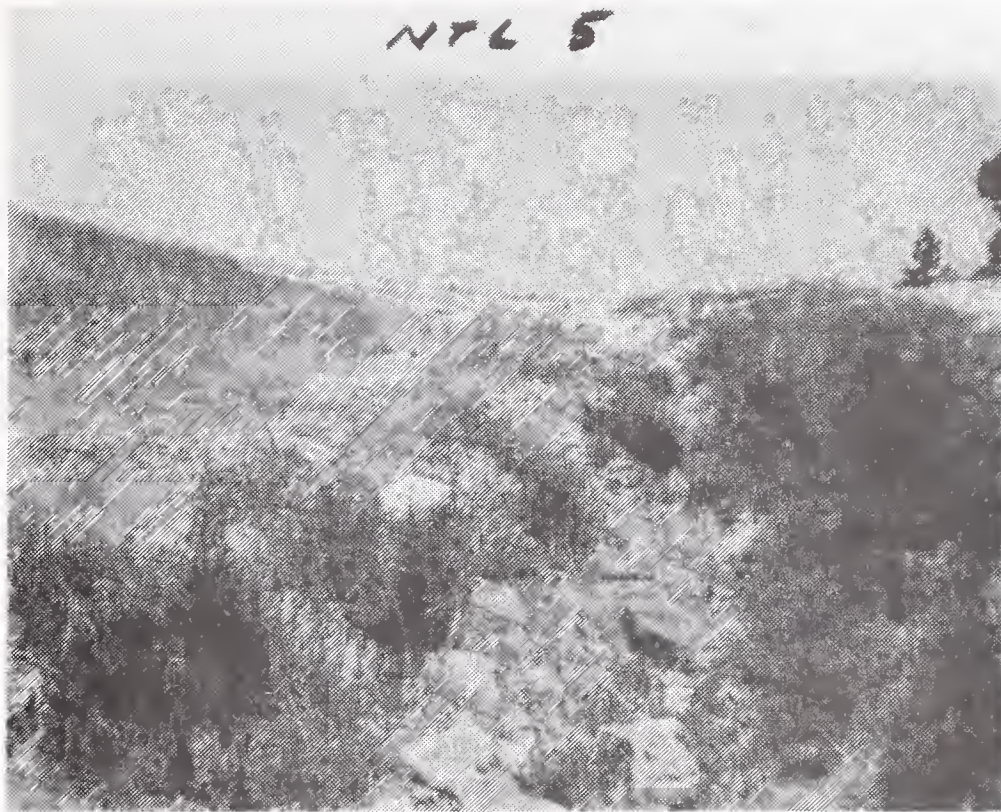
Considerable surface erosion is evident at the left abutment downstream contact. This erosion channel is up to 15 feet wide (Photo 7), and the channel has been partially filled with sand and gravel in an attempt to provide erosion protection. The erosion has continued, undermining this fill (Photo 8) and some of the downstream toe of the slope. Only minor seepage was observed at the right abutment, where extensive construction and post-construction treatment to cutoff seepage has been applied. The downstream slope is well covered with grass with the exception of a few small areas where runoff erosion has occurred.

PHOTO 7
Left Abutment Downstream Erosion

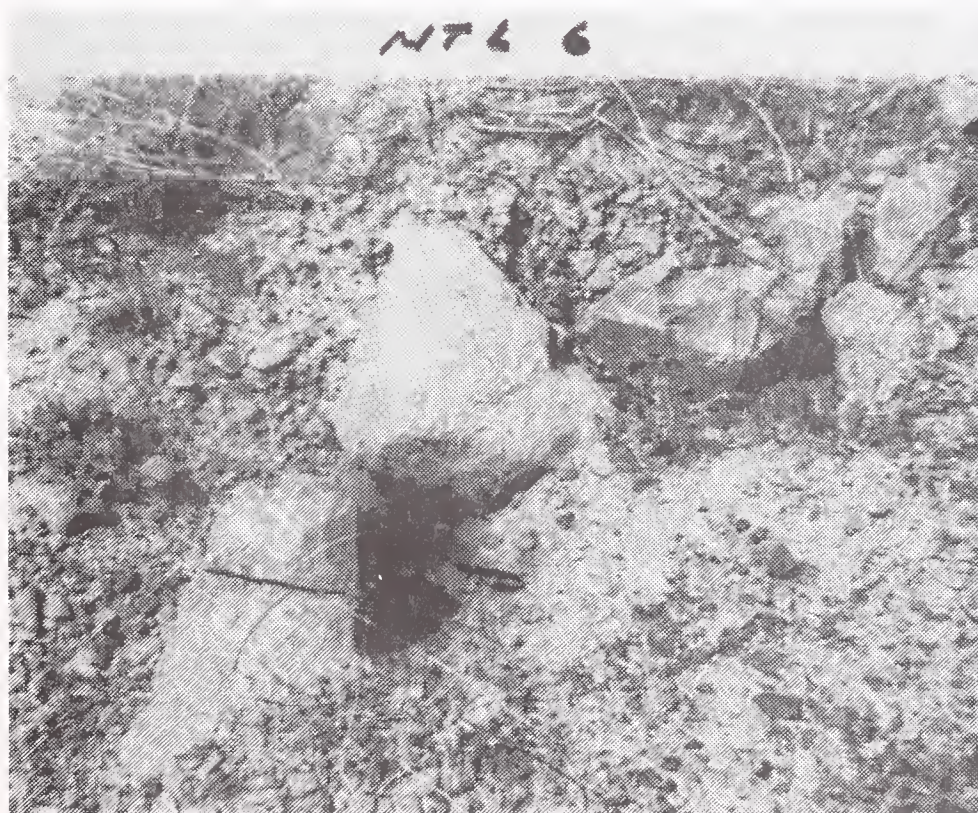
PHOTO 8
Left Abutment Erosion Undermining Backfill

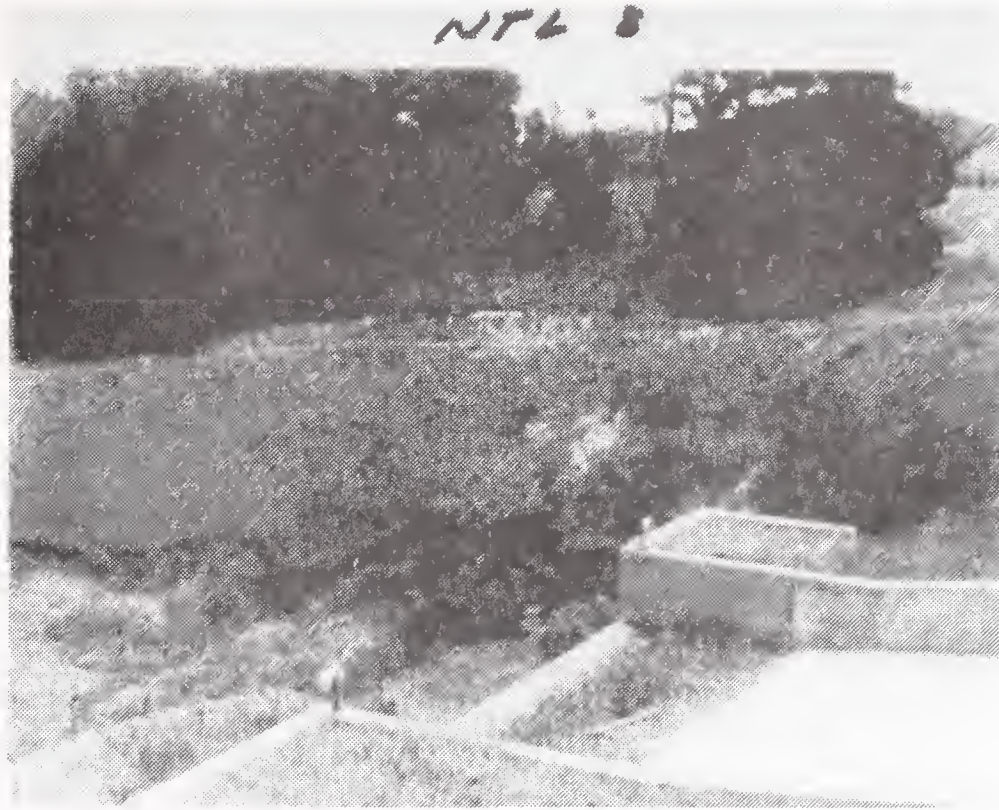
PHOTO 9

The crest of the spillway ogee section is at elevation 3281.0 feet NGVD. The top of the flashboards is at elevation 3285.0 feet. The chute has a bottom gradient of approximately 0.20 feet per foot for 80 feet to the flip bucket. The impact area immediately downstream from the end sill of the flip bucket appears to be highly susceptible to erosion. (Photo 1) The pipe drains for the flip bucket were plugged and silt had collected in the depressed area. (Photos 9 & 10) The spillway concrete appeared to be in good condition.

Emergency Spillway Erosion Downstream from Stilling Basin

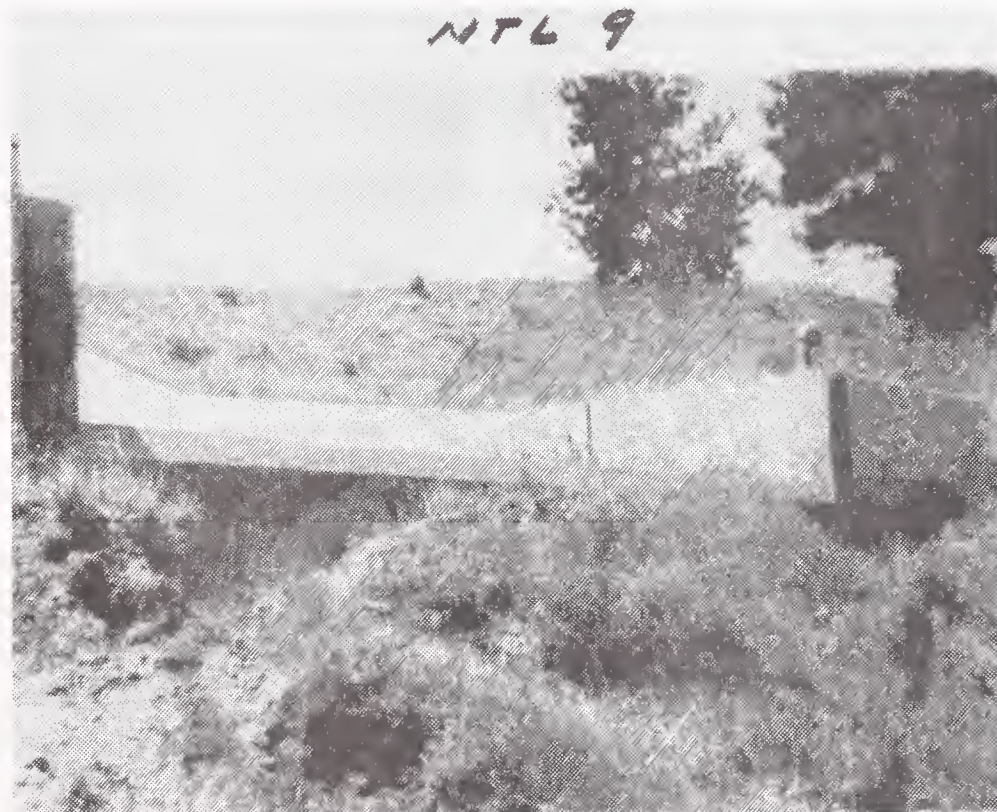
PHOTO 10

The emergency spillway structure, apparently founded on medium hard sandstone bedrock, is in a saddle west of the Main Dam's left abutment. There is about 3 feet of silty sand and weathered sandstone over the bedrock at the site. The approximately 1V on 2H sideslopes along the east side of the unlined stilling basin have become moderately eroded under the action of surface runoff, and there is some sloughing of slope surface materials (Photo 9). There has been some erosion of soil to the sandstone bedrock beneath the flip bucket and behind the wingwalls at the outlet of the chute (Photo 10).

Erosion Beneath the Flip Bucket and Behind the
Wing Walls at the Emergency Spillway
